Radon levels in three fish rearing buildings at Cleghorn Springs State Fish Hatchery, Rapid City, South Dakota, USA

Alexis L. Gerber, Shaylee Martling, Jill M. Voorhees, Hope Marchant and Michael E. Barnes*

South Dakota Department of Game, Fish and Parks, McNenny State Fish Hatchery, Spearfish, SD, USA

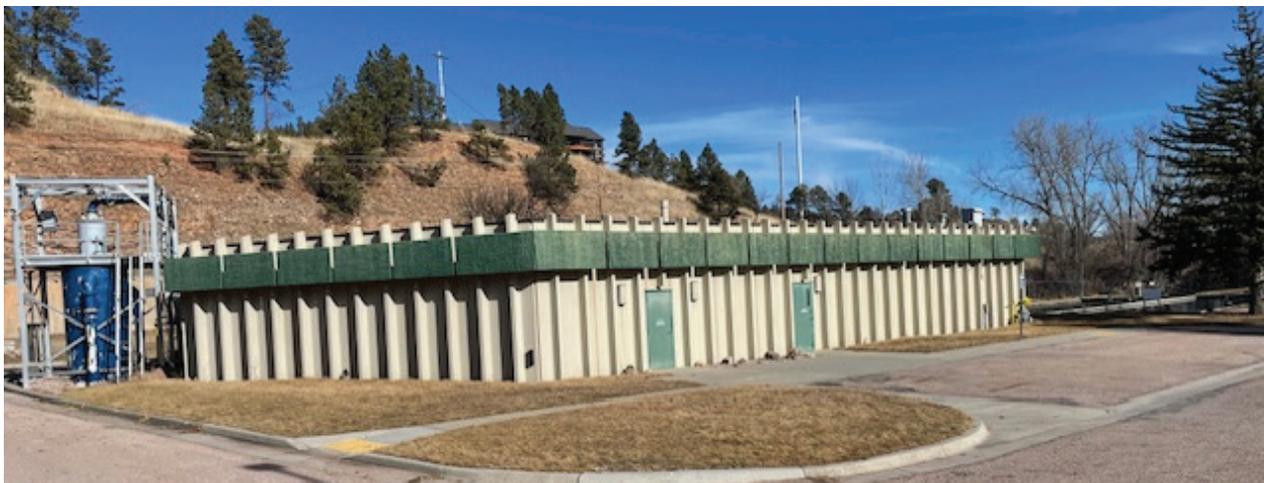
relatively-large, enclosed space at 23.0 m by 14.8 m , with concrete floors and ceramic block walls. The roof is prefabricated with concrete beams. All of the fiberglass circular tanks are above ground, with water flowing into each tank through a 5.08 cm -diameter spray bar. Each tank is 1.8 m in diameter and has a water depth of 76.2 cm . The spray bars are located 5.1 cm above the water level in the tank. Each spray bar is 61.0 cm long with 11 evenly distributed holes. These spray bars are set to a slight angle to keep water flowing in a circular fashion to make them self-cleaning (22). Water levels are controlled by an external standpipe, with one standpipe per tank. Each 7.6 cm -diameter standpipe is 66 cm tall and is contained in a 17.1 cm -diameter, 106.7 cm -tall housing, which is open on the top to allow for cleaning. There is no ventilation in the tankroom except when external doors are opened.

Fig. 2. Photograph of the tankroom at Cleghorn Springs State Fish Hatchery.

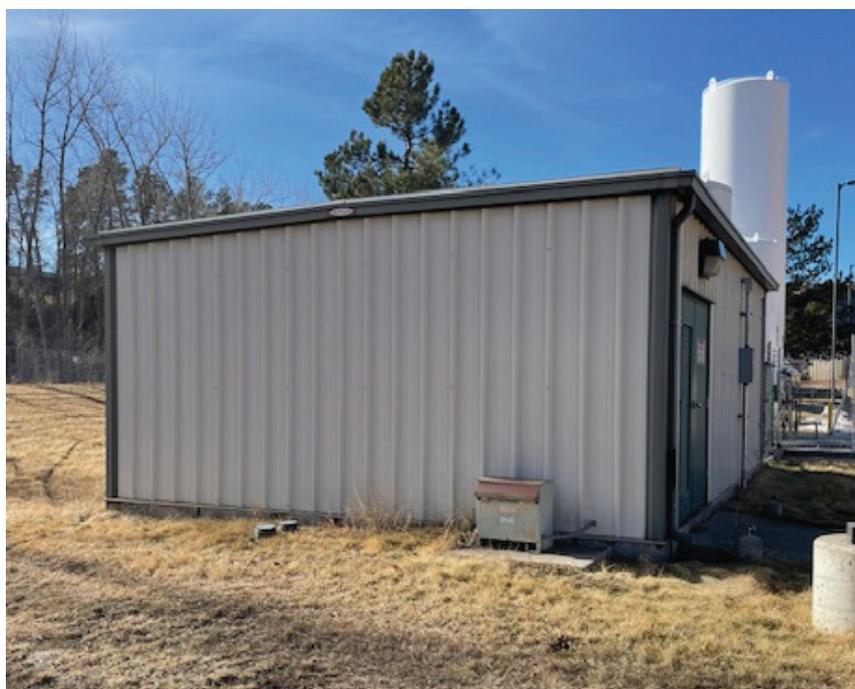
The small tankroom is the smallest rearing building at Cleghorn Hatchery. It is only 6.0 m wide by 9.15 m long,

Fig. 3. Photograph of the small tankroom at Cleghorn Springs State Fish Hatchery.

with a ceiling height of 3 m. It has nine, 1.8-m diameter above-ground circular tanks resting on concrete floors with a drain system and standpipes similar to the tankroom. A range of 0–9 tanks were used for fish production during the study period (Table 3). This building has no ventilation except when the two external doors are open.

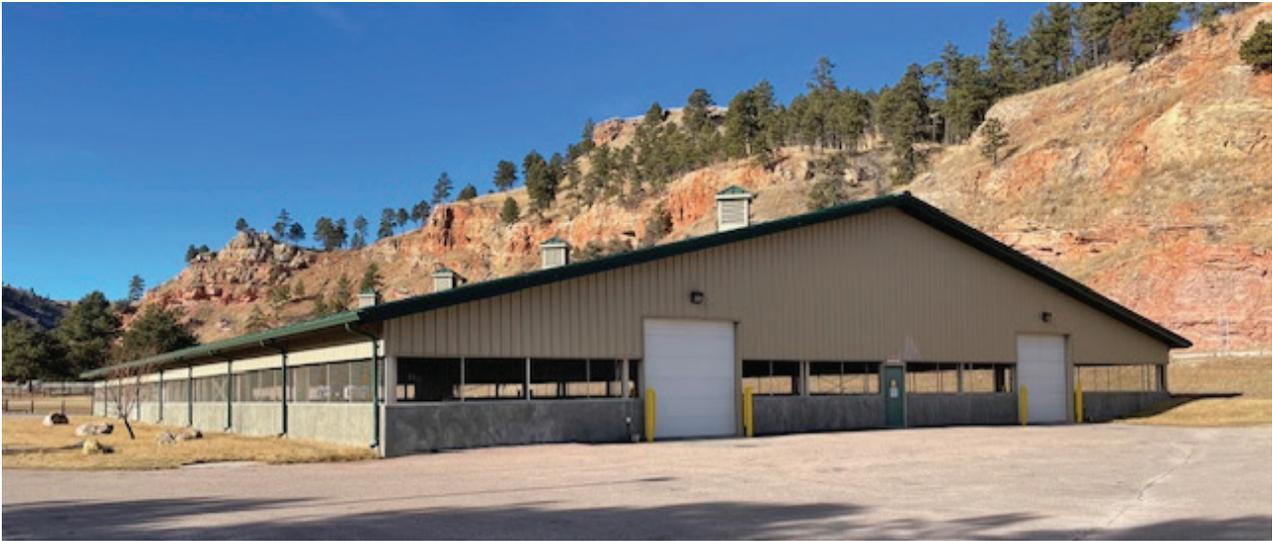
The rearing pavilion is a relatively open-air building containing 32 in-ground tanks. A range of 0–32 tanks were used for fish production during the study period (Table 2). The building is 62.8 m by 37.3 m with a wall height of 3.0 m . The roof is peaked, with the peak falling 18.7 m from either wall. The floors are concrete, but the building is constructed of steel support beams and metal sheeting, with screen inlays along all walls for light and ventilation. The pavilion tanks are 6.1 m in diameter and 1.2 m tall, with operating water depths of 73.7 cm . The spray bar for each tank is 1.2 m long and 11.4 cm in diameter, with three discharge holes. Each spray bar is 10.2 cm above the water level, with water entering the tank at 5.1 cm above the water level. Every tank has an adjacent 16.5 cm -diameter 1.1 m tall standpipe located within an in-ground concrete cylinder that is 1.5 m in diameter and 1.7 m tall.

Fig. 4. Photograph of the Rearing Pavilion at Cleghorn Springs State Fish Hatchery.

Compared to the tankroom and small tankroom, the pavilion radon levels were much lower. This is easily explained by the continually open screened ventilation encompassing nearly the entire perimeter of the building. Any radon gas liberated during rearing tank spray bar aeration immediately dissipates into the atmosphere (34).

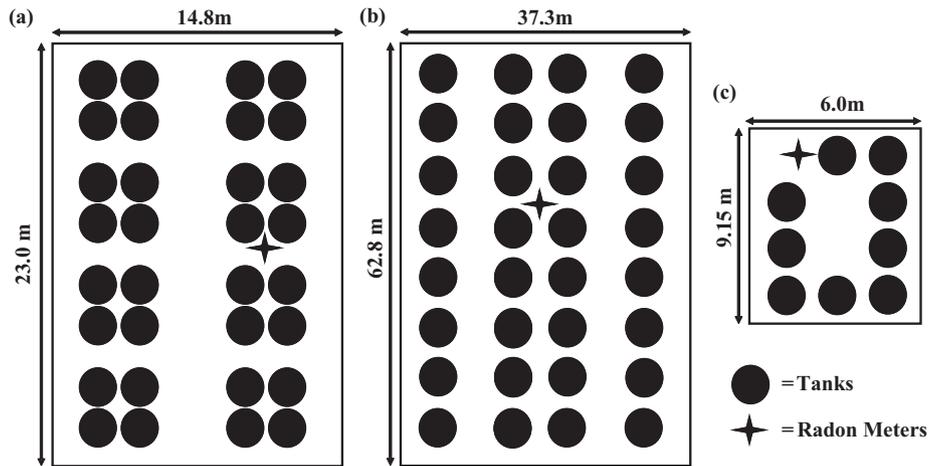
Fig. 5. Schematic of the (a) tankroom, (b) pavilion, (c) small tankroom at Cleghorn Springs State Fish Hatchery (not to scale). The point where radon readings were collected is marked with a four-point star, and tanks are marked with a black circle.

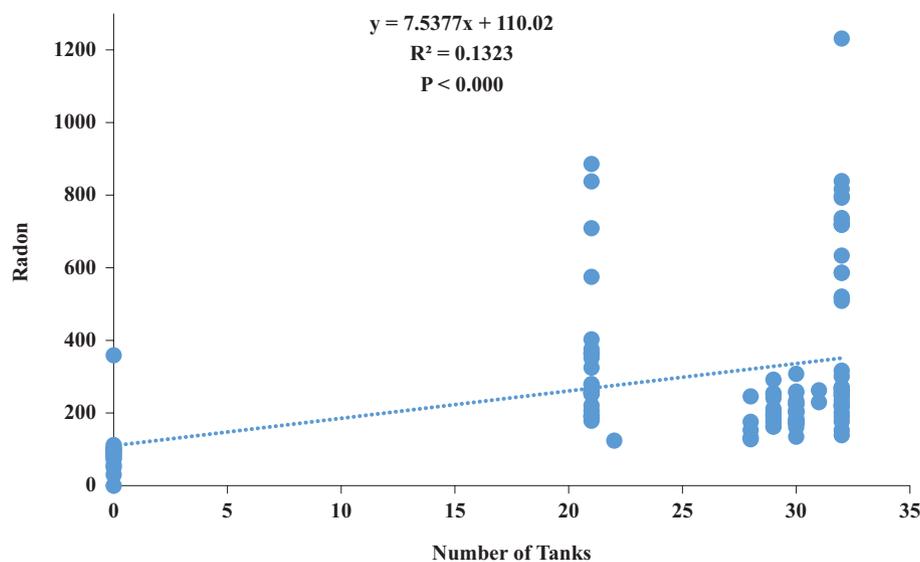
The number of tanks in production in each building varied from zero to maximum levels over the sampling period. Radon levels were significantly correlated with the number of tanks receiving water in both the tankroom ($R^2 = 0.132$;

$P < 0.000$; Fig. 6) and small tankroom ($R^2 = 0.564$; $P < 0.00$; Fig. 7). However, there was no correlation ($R^2 = 0.002$; $P < 0.636$) between the number of tanks with flowing water and radon values in the pavilion (Fig. 8).

In all three buildings, radon levels were below 148 Bq/m^3 (4 pCi/L) when none of the tanks was receiving water. Radon levels generally stayed low in the relatively open-air pavilion regardless of the number of tanks with water. However, in the enclosed tankroom, particularly the small tankroom, radon levels increased as soon as water was flowing in any of the tanks.

Fig. 6. Radon readings (Bq/m^3) in relation to the number of tanks with flowing water in the tankroom at Cleghorn Springs State Fish Hatchery.

(24 pCi/L) in the tankroom was higher than the recommended maximum levels as well. However, despite these relatively high radon levels, current management practices at Cleghorn Hatchery result in very short radon exposure times for employees in the tankroom and small tankroom, likely lowering the need for intense mitigation (23, 25). Hatchery employees are typically only in the small tankroom for a few minutes each day to fill feeders or clean tanks. Feeding and cleaning in the larger tankroom takes less than an hour. However, there are limited occasions, such as moving fish, tagging, or other activities, when hatchery staff spend most of the day in the tankroom. Because these buildings are currently enclosed with no ventilation, it is likely that installing an exhaust fan or ventilation system would dramatically reduce radon levels, further reducing

the risk in addition to current low exposure times for hatchery staff (25–30).

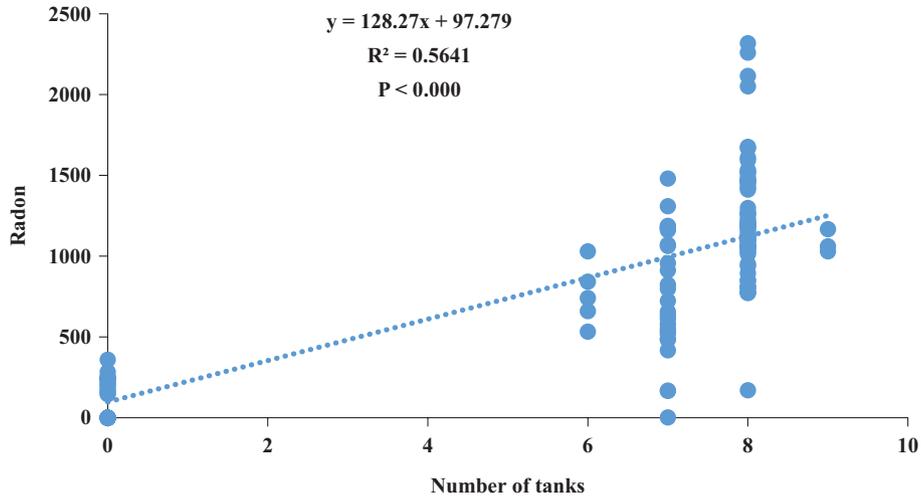
Fig. 7. Radon readings (Bq/m³) in relation to the number of tanks with flowing water in the small tankroom at Cleghorn Springs State Fish Hatchery.

remediation may be needed within the tankroom and small tankroom. Continuing to limit staff time in the tankroom and small tankroom at Cleghorn Hatchery is recommended. In addition, the current practice of housing offices, shop, and conference area in buildings separate from fish rearing structures should also continue.

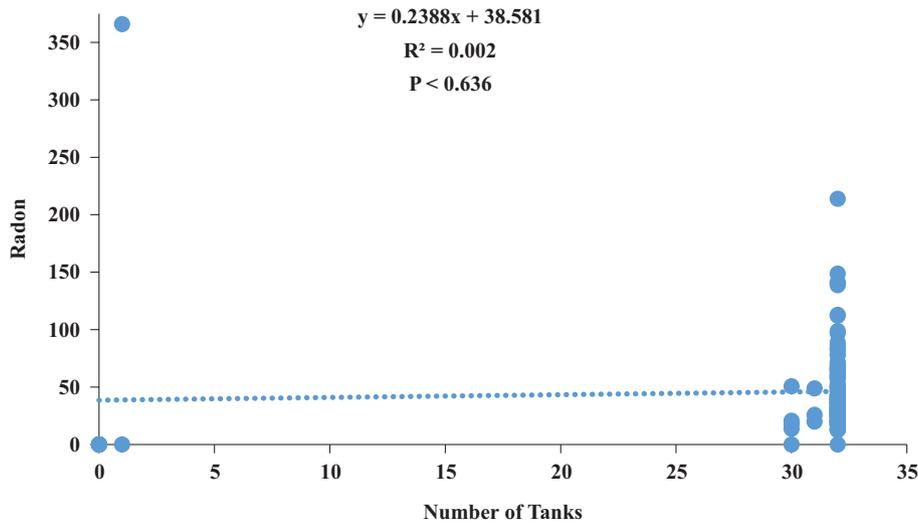
Fig. 8. Radon readings (Bq/m³) in relation to the number of tanks with flowing water in the pavilion at Cleghorn Springs State Fish Hatchery.
