## Follow-up study on indoor radon levels in Irish schools after a National School Survey and remediation programme

### Abstract

**Objectives:** To determine the durability of the remediation systems 10–17 years post-installation and to study the effect of radon awareness on follow-up programmes, radon retests were performed in 16 schools that had some form of remediation implemented.

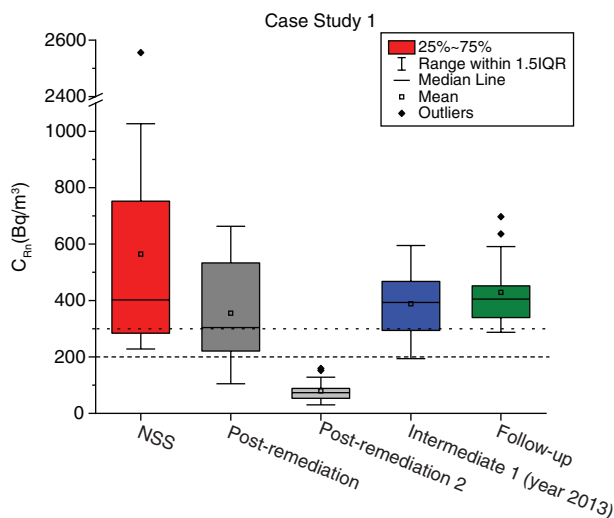
The school is a large secondary school in a HRA of Co. Kerry that was remediated after the NSS. Remediation works consisted of the installation of eight sub-slab depressurisation sumps as advised by the radon contractor. The principal indicated that, to his knowledge, maintenance was not carried out on the remediation works but radon measurements were conducted in 2013 and the results were provided. Figure 1 shows a boxplot of the radon concentration in the school at the different stages. The mean radon concentration reported in the NSS was 580 Bq/m<sup>3</sup>, and two remediation attempts were needed to reduce radon concentration below the reference level, achieving a mean radon concentration of 80 Bq/m<sup>3</sup> (post-remediation 2). However, the radon measurement conducted in 2013 (Intermediate 1) and the follow-up survey measurement reported an increase in the mean radon concentration over the reference level, reaching a mean radon concentration of 430 Bq/m<sup>3</sup> in 2015.

Fig. 1. Boxplot of radon concentration measurements for case study 1 – Co. Kerry.

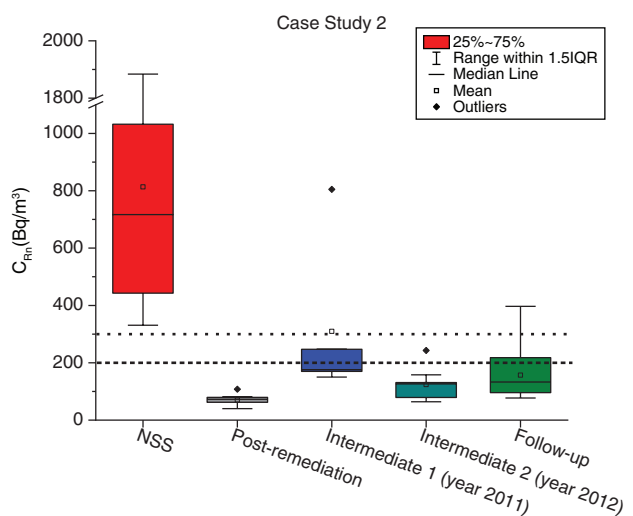
The school is a medium size secondary school located in a HRA of Co. Kerry remediated after the NSS. Remediation works consisted of the installation of seven sub-slab depressurisation sumps. The principal indicated that a local radon adviser was contracted by the school for the maintenance of the remediation works and that radon measurements were conducted on two occasions after the NSS in years 2011 and 2012. The results of both measurements were provided. Figure 2 shows a boxplot of the radon concentration in the school at the different stages. Mean radon concentration reported in the NSS was 813 Bq/m<sup>3</sup>, and after the remediation, it was reduced to 70 Bq/m<sup>3</sup>. In 2011, it was found that radon levels had risen (Intermediate 1) and the school repaired the remediation system in the affected rooms. The following year radon tests were repeated (Intermediate 2) and confirmed the success of the repair works, achieving a mean radon concentration of 124 Bq/m<sup>3</sup>, well below the reference level. The follow-up survey measurements reported a slight increase in the mean radon concentration but still below the reference level for schools.

Fig. 2. Boxplot of radon concentration measurements for case study 2 – Co. Kerry.

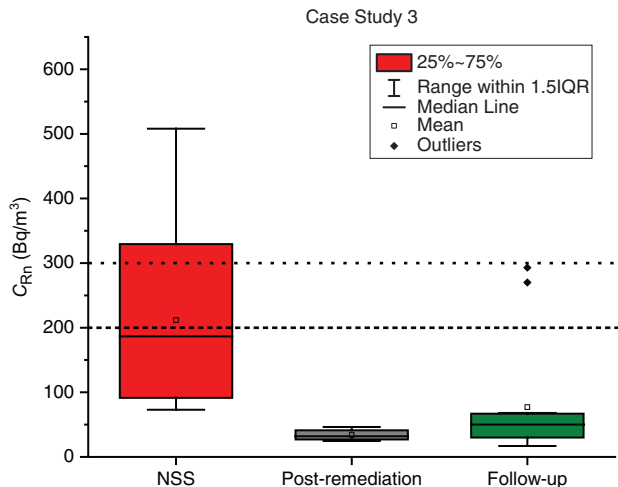
**Fig. 3.** Boxplot of radon concentration measurements for case study 3 – Co. Wicklow.

added to the school, and trickle vents were present in accordance with building regulations (11). Figure 3 shows a boxplot of the radon concentration in the school at the different stages. Mean radon concentration reported in the NSS was 212 Bq/m<sup>3</sup>, and after the remediation, it was reduced to 34 Bq/m<sup>3</sup>. In the follow-up survey, it was found that mean radon concentration doubled, reaching 77 Bq/m<sup>3</sup>, and that radon concentration in two rooms was above the reference level as a result of the mentioned sump failure.
