TECHNICAL PAPER

Evaluation and study of radon occupational exposure levels in dams: a case study of the Gallery of Medau Zirimilis Dam (Sardinia, Italy)

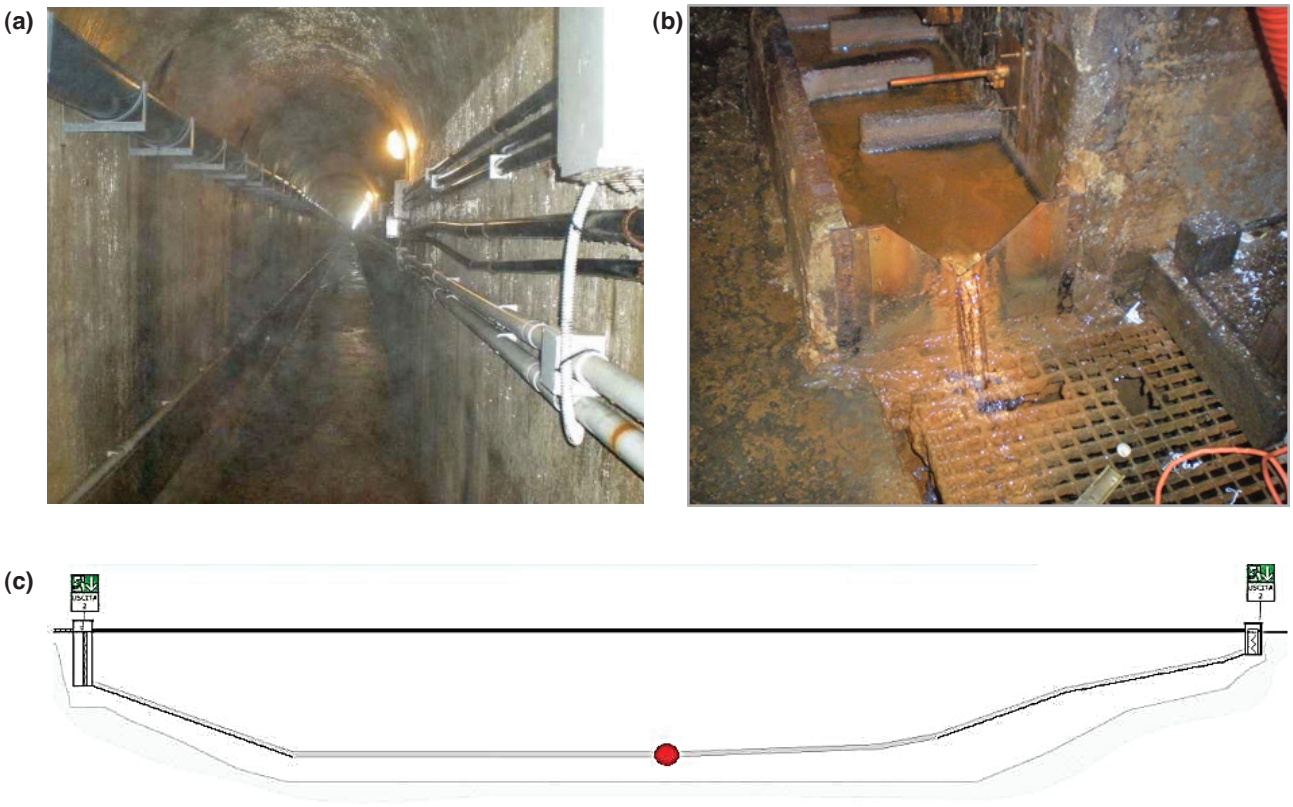
The preliminary inspections done in the previous study showed elevated radon levels in the dam gallery. Specifically, the outgassing and dispersion of radon dissolved in water (or, more accurately, radon derived from sediments) flowing through drainage systems was most likely to cause high indoor radon concentrations. In an attempt to verify this hypothesis, sediment samples from three different parts of the drainage canal of the gallery (see Fig. 2) together with a water sample were collected. In addition, the indoor radon concentration was monitored in the centre of the gallery, located at the red point in Fig. 2c, using two continuous radon monitors (CRMs) (MR1 plus and Radex MR-107). The collected sediments were first mixed, then oven-dried for 24 h at 110°C, sieved (mesh size finer than 200 microns) and eventually introduced to radon exhalation rate testing. The natural radionuclide concentrations of the homogenised sediment sample were also measured using the gamma-ray spectrometry technique. Furthermore, the concentration of radon in the water sample taken from the drainage system of the dam was determined.

Fig. 2. (a) The gallery of Medau Zirimilis Dam, (b) the drainage canal of the dam gallery containing considerable contents of sediments and (c) the section plan of the dam and the radon measurement point is also specified.

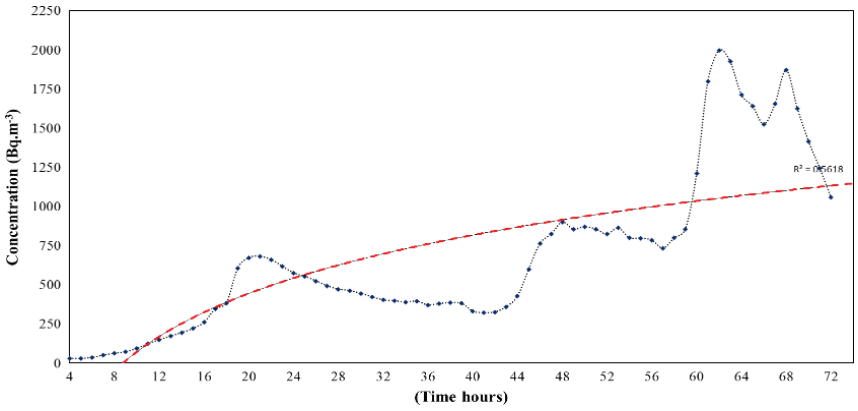
The indoor radon level in the gallery of Medau Zirimilis dam was monitored for 72 h using two continuous radon monitors. Due to the loss of the electric power supply during the test operation, the MR1 plus was turned off. Because of this, only the values recorded by Radex MR-107 are presented here (see Fig. 3). According to this figure, although there are fluctuations in the reordered indoor radon concentrations, the radon activity in the dam gallery tends to increase over time due to gas accumulation in a closed space (dam gallery). It is worth adding that the enclosed space condition was maintained

Fig. 3. Results of indoor radon concentration monitoring inside the dam gallery and the trend line of radon activity growth (red line).

during the testing to allow the build-up of radon and simulate actual conditions. The fluctuations seen in the measured radon values are mainly because of disequilibrium between the radon decay products. This can be because of the large dimensions of the dam gallery and therefore longer testing time, which would be required. However, the trend line chart in Fig. 3 shows that radon grows up and tends to reach a flat line, but as mentioned earlier, longer measurement period would have been required to see a rather full flat line in the radon activity growth chart. It usually takes 3–7 days to reach a relative equilibrium in a closed space. In general, the results of indoor radon monitoring show a remarkably high value of the mean indoor concentration of radon of about 683 ± 516 Bq.m^{-3} with minimum and maximum values of 30 and 1,998 Bq.m^{-3}, respectively (see Table 1). To identify the source of indoor radon, sediment samples together with a water sample were collected. The sediments were introduced to the gamma-ray spectrometry and radon exhalation rate tests. The results of the measurements are shown in Figs 4 and 5. A significantly high ^{226}Ra concentration (226 ± 7 Bq.kg^{-1}) was found in the sediment sample. However, the concentration of ^{232}Th (37 ± 5 Bq.kg^{-1}) and ^{40}K (210 ± 198 Bq.kg^{-1}) was relatively low. These concentrations may be justified by the behaviour of these radioisotopes in the environment. In fact, when the water passes through the bedrocks hosting uranium-bearing minerals (the shales from the Genna Muxerra formation can be an example for this study – see also Fig. 1), ^{226}Ra from the host rocks can be easily dissolved in water due to its relative solubility and transported through the aquifer. Whilst ^{232}Th is very stable, it does not dissolve in a solution (30) and therefore cannot be transported by water. The low concentration of ^{40}K can also be related to the low concentration of this element in the host rock.

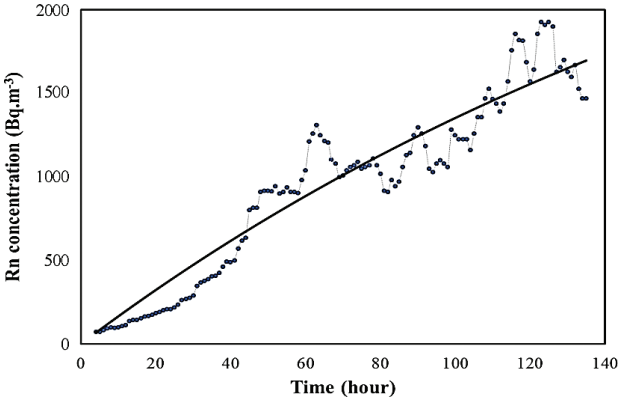
Fig. 4. Monitored radon concentrations released from sediment sample and the fitted radon growth model, based on the results of radon exhalation rate testing.

employed. Using the non-linear least-square fitting of Equation 1 on the measured data, the steady-state radon concentration was predicted to be 3,652 ± 160 Bq.m^{-3}, and then utilising Equations 2 and 3, the radon emanation factor and the radon production rate of the sediment sample were calculated (Table 2). A considerably high value of radon production rate was estimated (1,380 ± 239 Bq.m^{-3}.h^{-1}). This can be explained by the presence of high ^{226}Ra content and small particle size (less than 200 microns) of the sediments that can cause higher emanation of radon and subsequently higher gas production rates.

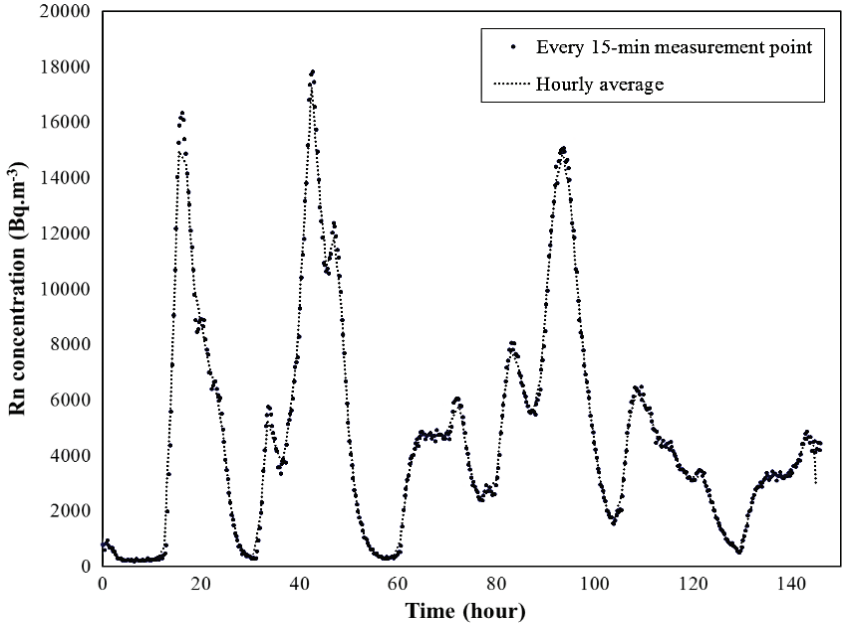
Fig. 6. Monitored radon in water concentrations, and the water sampled from the drainage system.

The radon concentration of the water sample containing 300 mL of mixed active water was measured for about 140 h according to the Lucas cell method. As presented in Table 1, the mean concentration over the measurement period is about 4.96 kBq.m^{-3}. This concentration ranges between 0.2 and 17.2 kBq.m^{-3}. Figure 6 shows the recorded values of radon in water concentrations in which high variations can be seen. The reason for this is the presence of the non-equilibrium state between radon and its progeny. In fact, the measurement of radon in water is very complicated. Technically, the setup for radon in water measurement aerates the water to allow radon released into the air, and then radon in the air is measured. Continuous operation of the pump to aerate the water does disturb the equilibrium state between radon and its progeny, and this is why we see high fluctuations. Therefore, probably internal factors like the pumping rate and the parameters related to the aeration from the water surface are responsible for the variations.

In surface waters such as lakes and rivers, the radon concentration levels are generally very low values in the range of 5 to 10 Bq.m^{-3} since radon can readily escape from the water surface and subsequently diluted in the free air (31). However, some lakes with high levels of uranium or other radioactive minerals in the surrounding rocks and soil may have higher levels of radon. In the case of outgassing of radon in underground spaces (e.g. Waterworks), the radon released from water accumulates in indoor spaces and contributes to high concentrations. It is believed that the same phenomenon occurs in the gallery of Medau Zirimilis Dam. The radon originating from uranium-bearing minerals of the bedrock is transported through the aquifer and penetrates the gallery through the cracks and joints in the structure. Then, whilst the water is being collected by the drainage system of the dam, a part of this radon escapes to the indoor air due to the aeration process. Due to the lack of proper ventilation, the released radon can accumulate inside the gallery in concentrations that may exceed the reference levels.

This study aimed to first evaluate the indoor radon exposure levels of the staff working in the gallery of Medau Zirimilis dam. Elevated values of indoor radon were found in initial investigations. Therefore, further measurements were considered in this study in an attempt to identify the source of radon and explore how it enters the gallery. Geogenic variables such as the geochemical mineralogical properties of bedrock are the primary parameters that affect the concentration of radon in groundwater. The presence of fractures and fissured zones close to the surface provides pathways for radon transportation through the aqueous media. In the cases where water found a way to the surface, the radon can be exhaled into the air from the water's surface. Consequently, because of poor ventilation, radon can accumulate in indoor spaces and therefore can potentially increase lung cancer risk for workers. The possible ways to decrease radon concentration mainly include limitation of radon entries and/or increase of the ventilation rates. Implementation of fans and even taking benefits of natural ventilation by providing more air entries (removing the glasses in windows and replacing them with perforated meshes) can help to decrease the indoor radon concentration effectively. Besides, by identifying cracks, holes and joints of the gallery's structure and restricting water entry routes to the gallery (e.g. by means of cement paste), it would be possible to decrease the amount of water flowing in the discharge channel of the dam gallery and limiting radon release from water to the air. This would also increase the efficiency of the ventilation systems as there would be less radon in the air that needs to be mitigated.
